Hallux Valgus

Evaluation of Deformity

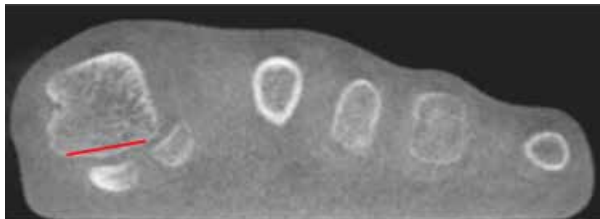
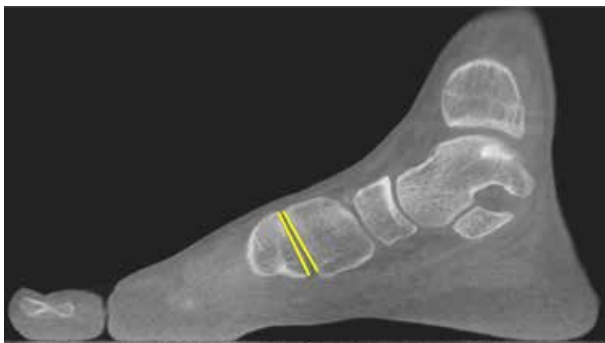
16 yo female with a family history of hallux valgus who presents with pain in her left forefoot.

WBCT scan demonstrated mild pronation of the first metatarsal (red line), sesamoid subluxation, and instability at the 1st TMT joint (yellow lines).

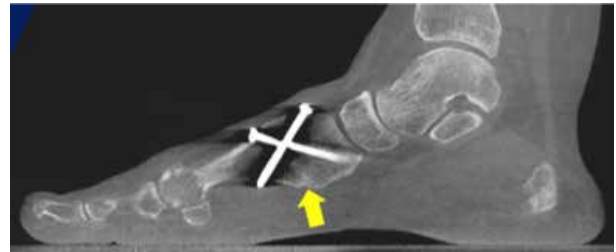
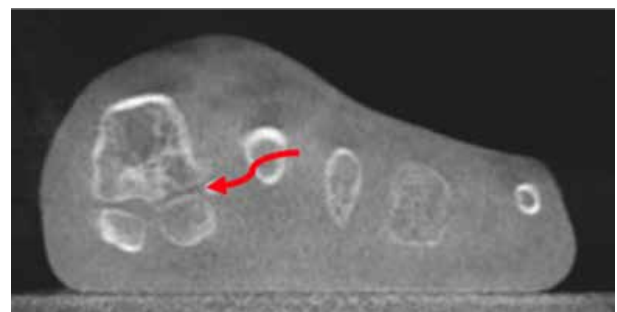
58 yo female who underwent a 1st TMT joint fusion for hallux valgus.

WBCT scan demonstrated degenerative changes at the metatarsosesamoid joints and reduction of the sesamoids (red arrow) and bony bridging across the 1st TMT joint (yellow arrow).
