Lisfranc Injuries

Subtle Lisfranc Ligament Injury

Post-Op Assessment

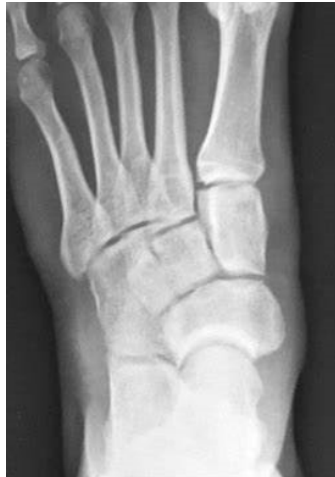
40 yo female with low energy foot injury who presents with midfoot pain. Radiographs were indeterminate.

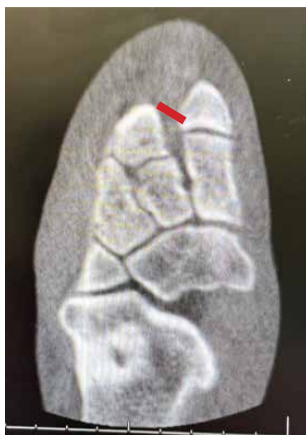
WBCT scan demonstrated widening between the medial cuneiform and second metatarsal base (red line).

There were no fractures identified on the WBCT. She underwent ORIF of her Lisfranc injury.
