Midfoot Arthritis

65 yo female with bilateral midfoot pain for 20 years, worse on the right side.

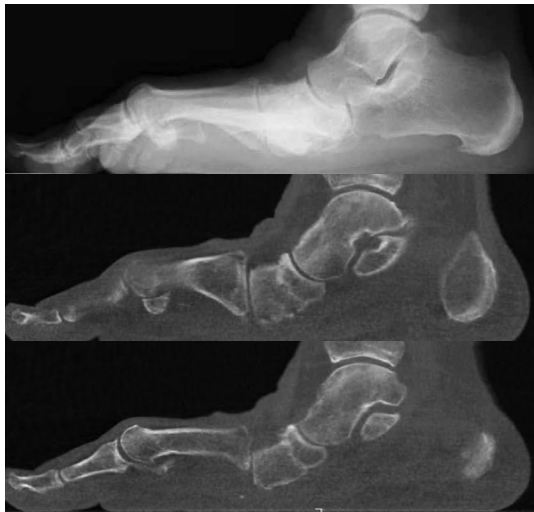
Images demonstrated severe degeneration of the midfoot joints. However, the severity of deformity and involved joints were difficult to determine on plain radiographs alone. As shown here, subluxation at the first and second TMT joints was better visualized on WBCT images than conventional radiographs.

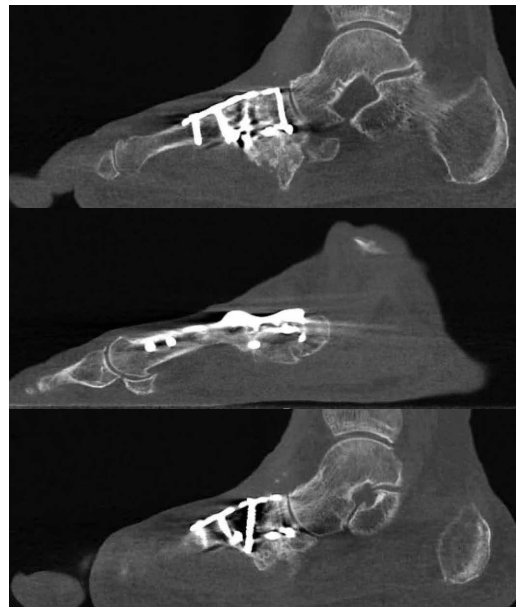
Post-Op Assessment

Obtaining a WBCT scan postoperative assists in the visualization of adequate restoration of the midfoot alignment, especially when surgical intervention was performed at multiple joints. Additionally, WBCT scans can assess bony bridging and fusion across the midfoot joints.
