## Hallux Valgus

### Evaluation of Deformity

### Postoperative Evaluation

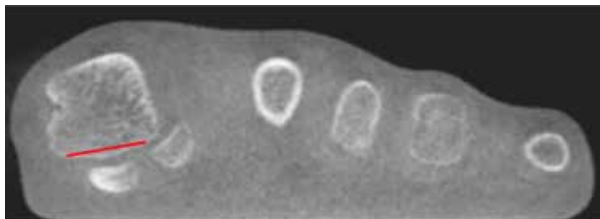
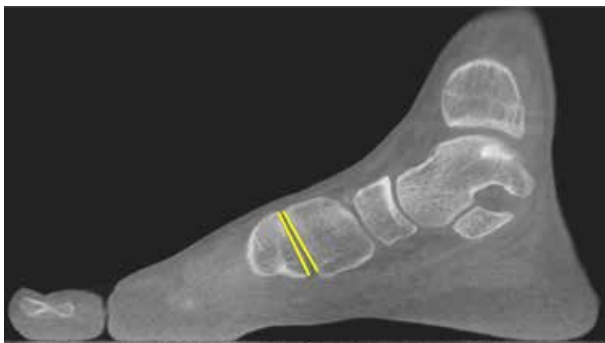
16 yo female with a family history of hallux valgus who presents with pain in her left forefoot.

WBCT scan demonstrated mild pronation of the first metatarsal (red line), sesamoid subluxation, and instability at the 1st TMT joint (yellow lines).

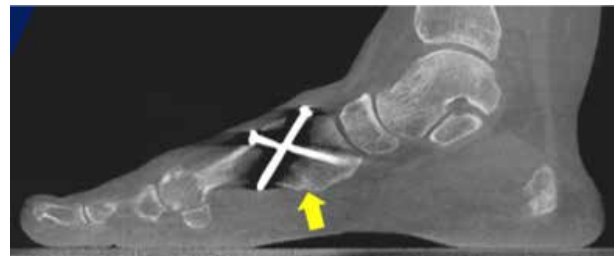
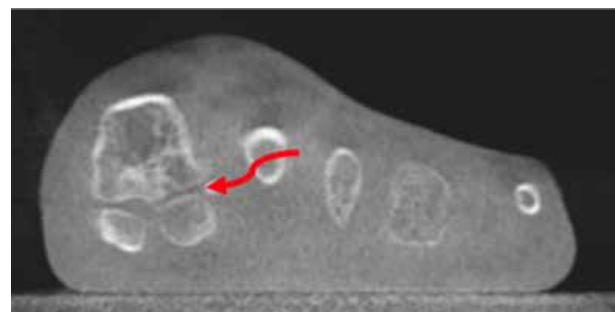
58 yo female who underwent a 1st TMT joint fusion for hallux valgus.

WBCT scan demonstrated degenerative changes at the metatarsosesamoid joints and reduction of the sesamoids (red arrow) and bony bridging across the 1st TMT joint (yellow arrow).
